Forensic Building Science, Inc.
657 Lincoln Avenue St., Paul Minnesota 55015

Client: Hollingsworth Investments VI Project Address: 88 Armory Road Vicksburg, Mississippi 39183 Warren County	Insurance Carrier: Cincinnati Insurance Company Policy #: Unknown Claim #: 2831900 Date of Loss: August 8, 2015 Claim Type: Hail, Wind, Water
---	--

FIELD REPORT FOR INITIAL STORM DAMAGE INVESTIGATION

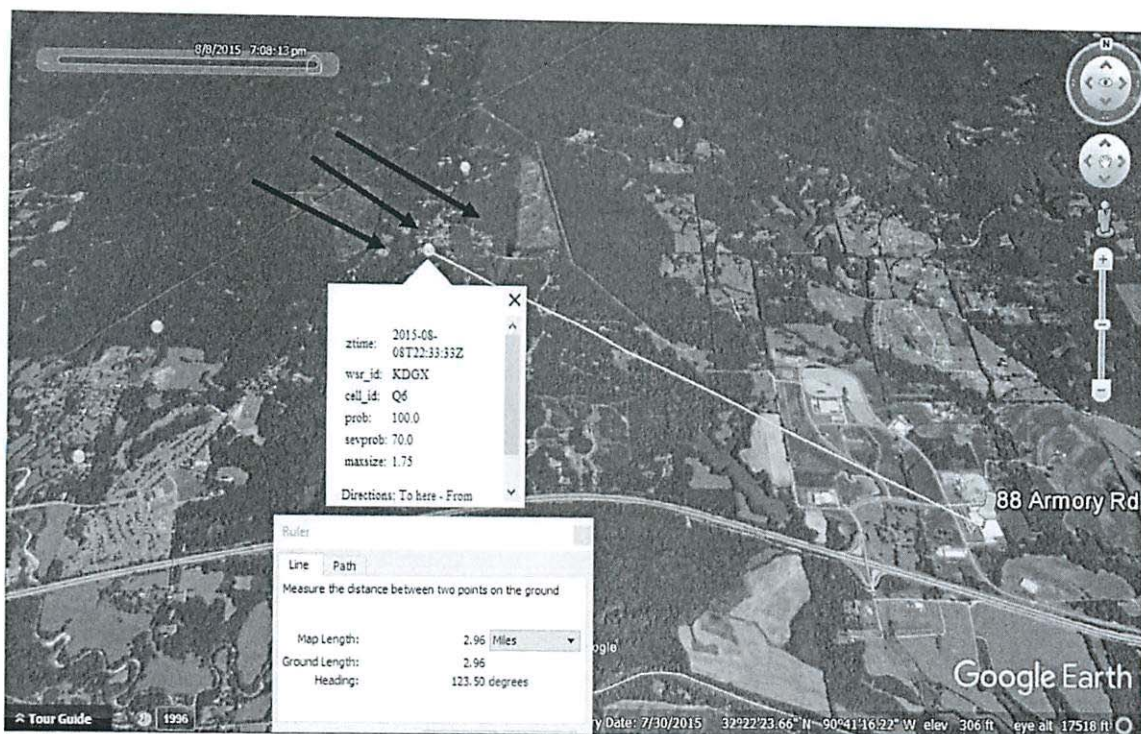
1.75 Inch hail at green balloon

Google Earth image of hail events (green dots) reported on August 8, 2015. The closest storm event is approximately 2.96 miles northwest of the property [Yellow pin]. Black arrows showing storm direction.

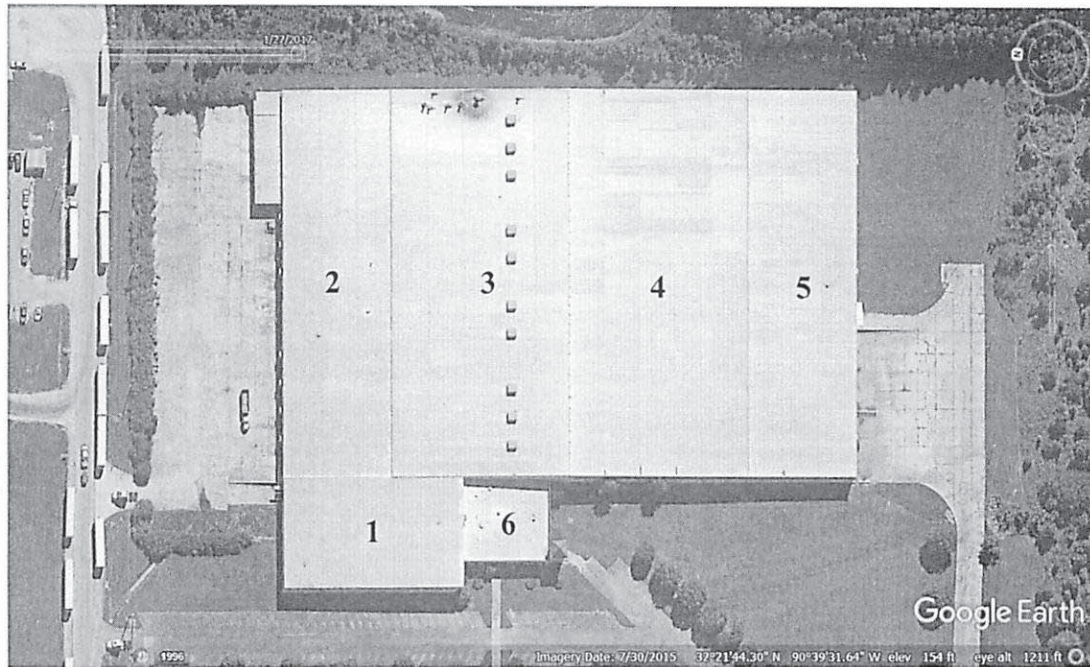
Google Earth imagery with numbered roof sections for corresponding sample squares.
